INFRARED ROOF INSPECTION

Newport Townhomes

June 16, 2020

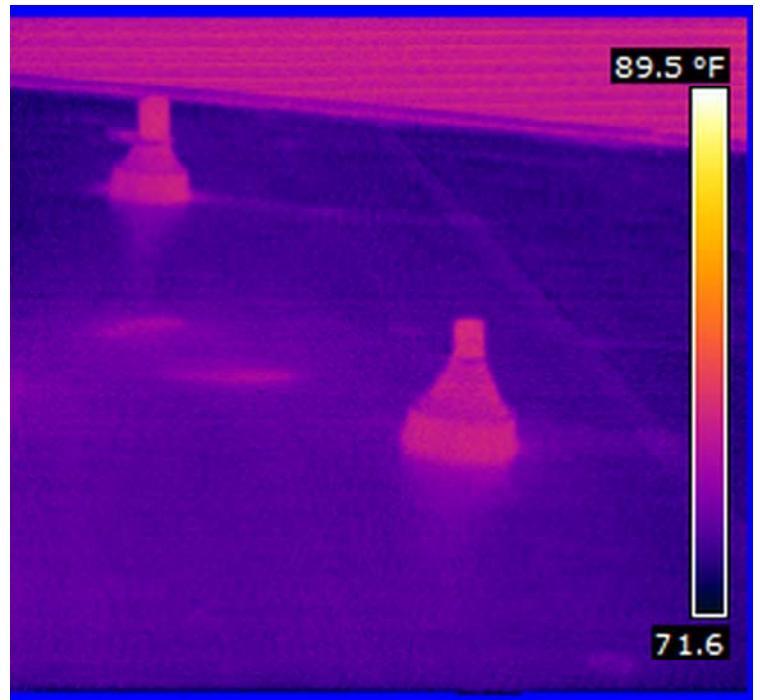
Building 1-East side overview. No suspected moisture intrusion issued noted.

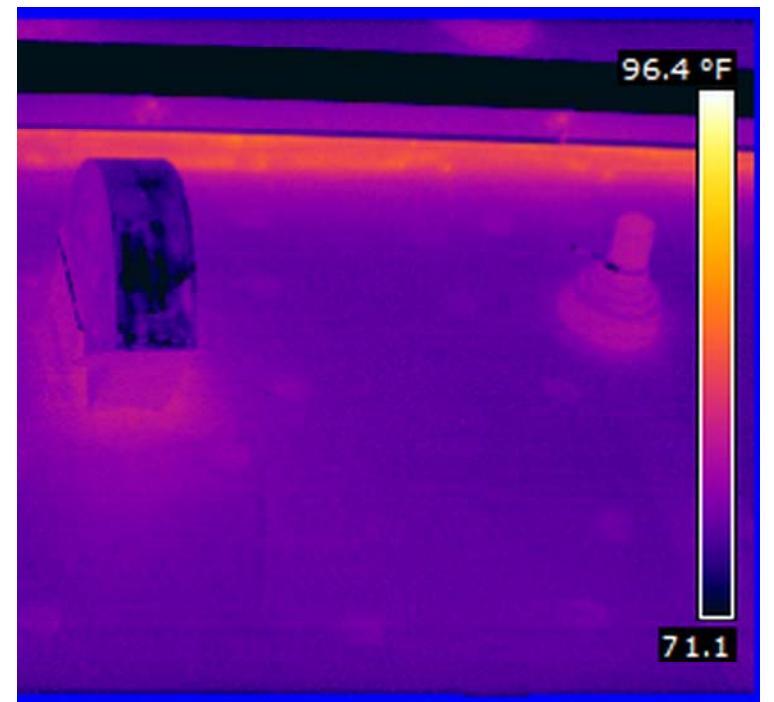
Building 1-Center overview. No suspected moisture intrusion issued noted.

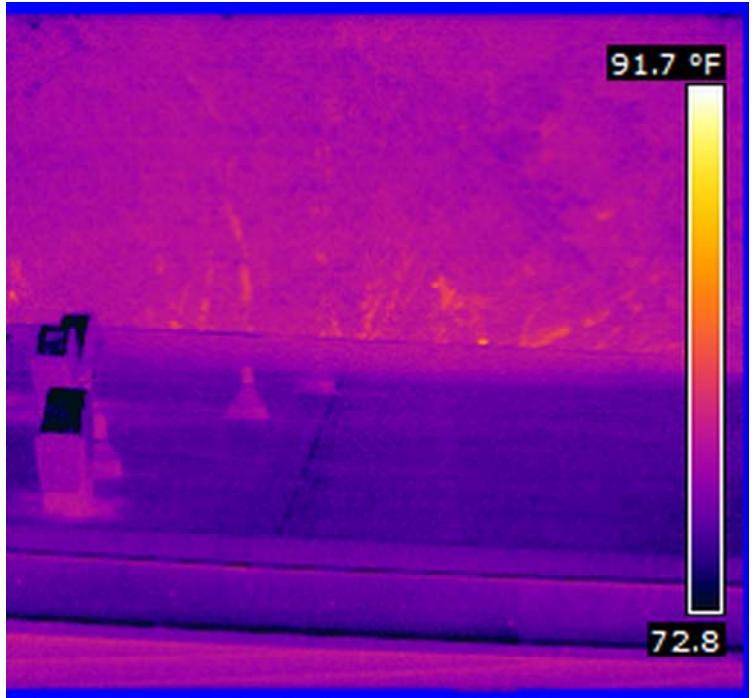
Building 1-West side overview. No suspected moisture intrusion issued noted.

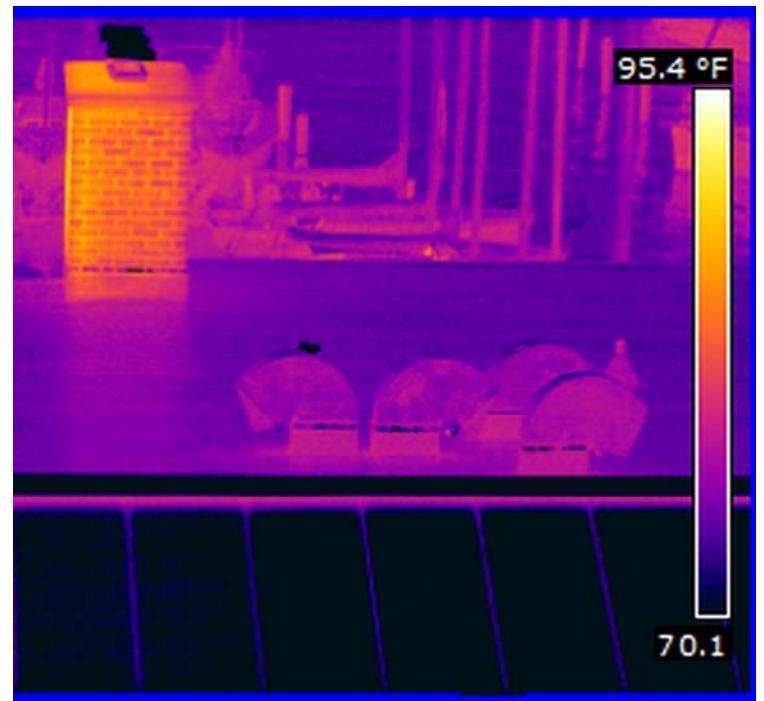
Building 2-East side overview. No suspected moisture intrusion issued noted.

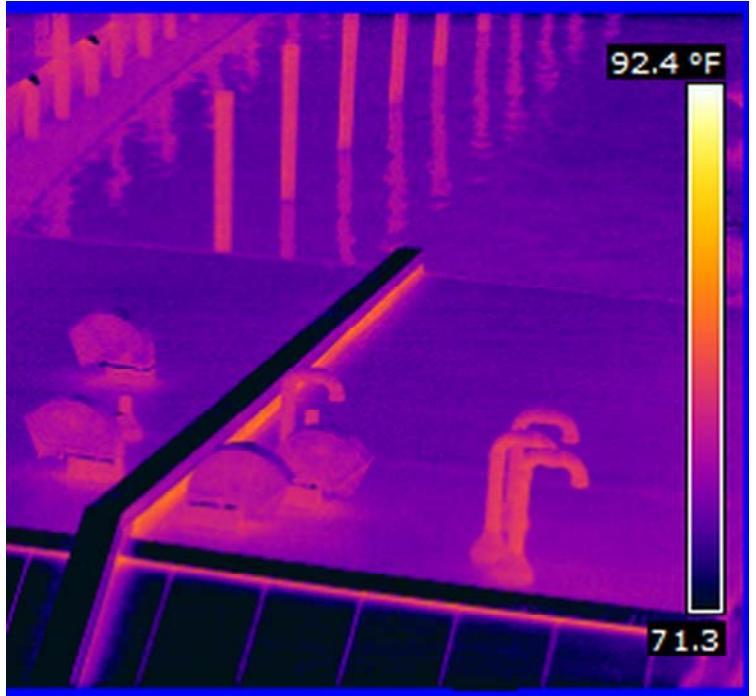
Building 2-Center overview. No suspected moisture intrusion issued noted.

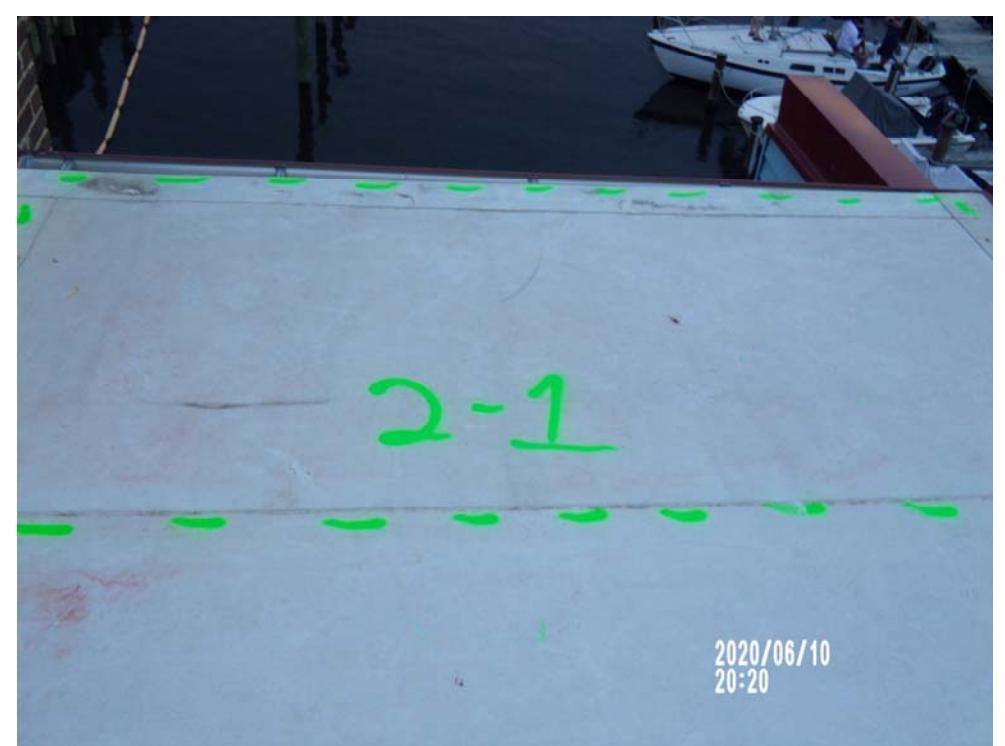
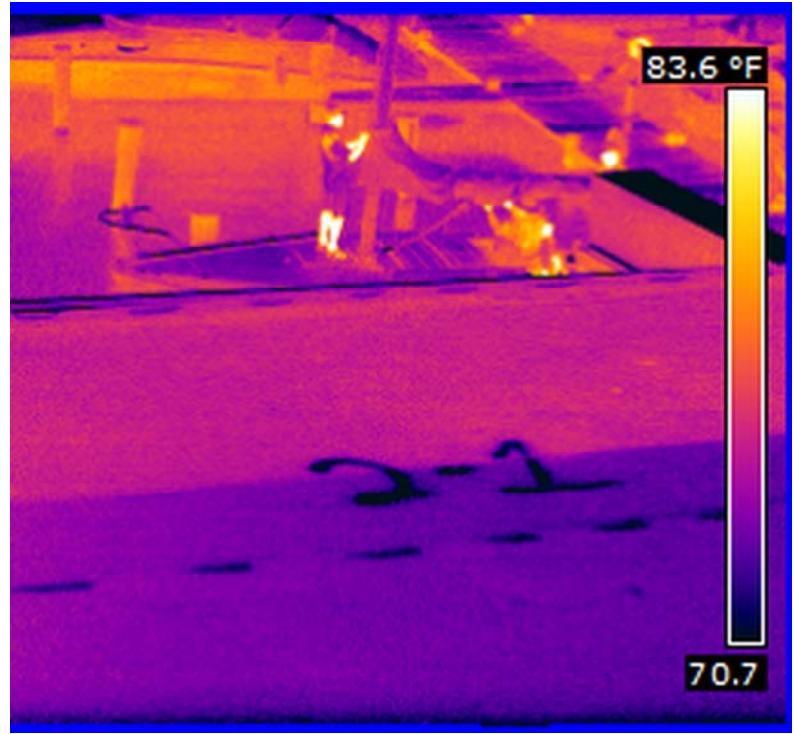
- o Building 1
 - No thermally detected anomalies, consistent with moisture intrusion, were noted.
- o Building 2
 - One (1) suspected wet area was noted on the West side of the roof, from the chimney to the Eastern edge of the roof. The nuclear gauge confirmed this finding.

Building 2-Suspected wet area #2-1.
